Damp Survey

John Smith
1 Anystreet
Anytown
Anycity
S39 9FZ

Date: 13/12/2023**Report ID:** 8268A**Property:**1 Anystreet
Anytown
Anycity SY S39 9FZ**Customer:**

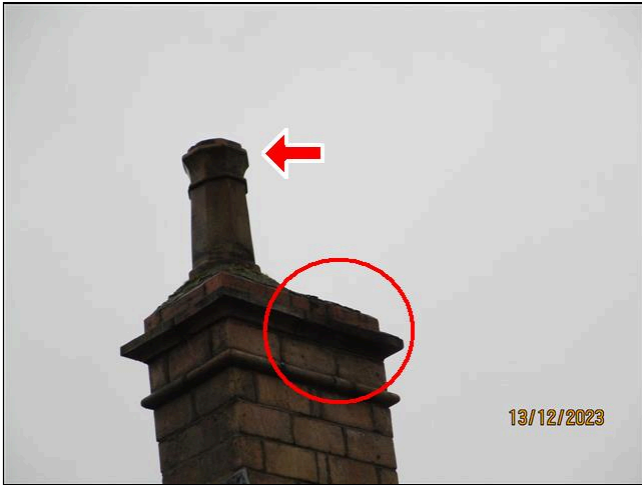
The unused chimney breasts are not vented to help reduce the risk of condensation. Some chimney breasts are dry lined and this may mask damp. The other chimney breasts recorded high moisture readings.

3.0 Item 1(Picture) Chimney no cowl and no vents

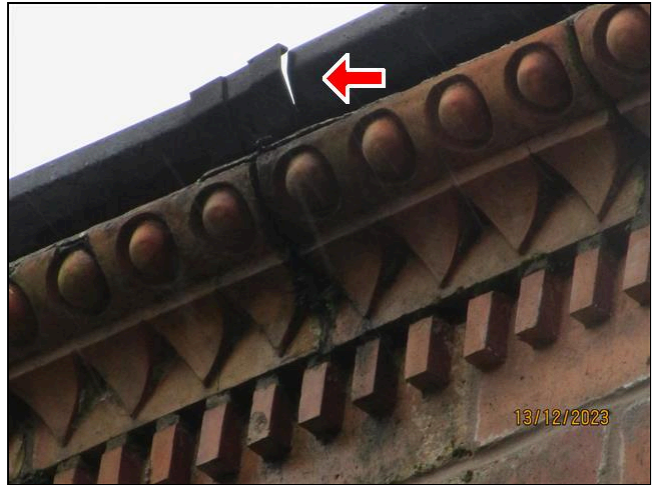
The gutters have some gaps especially at the rear above the Landing window. I also noted standing water here indicating the fall to the downpipe is not steep enough and this may cause rainwater to overflow onto

3.0 Item 2(Picture) Gutter leak at the rear

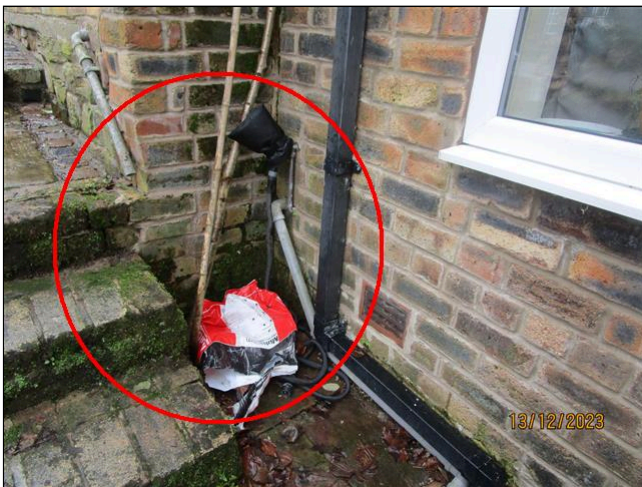
There is a step and wall to the Left corner of the Utility Room that abutts the main wall. This seems to be allowing penetrating damp into the corner wall and blistering plaster was noted internally. In addition to this the external water tap is leaking, further soaking the wall here.

3.0 Item 3(Picture) Raised step and leaking water tap

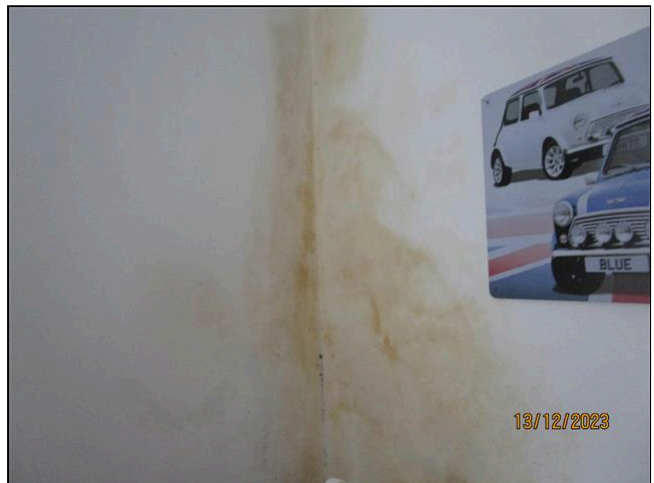
3.0 Item 6(Picture) Damaged plaster in places

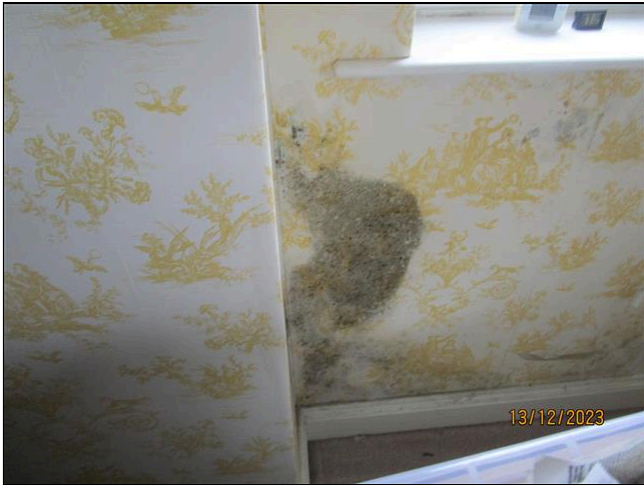
3.0 Item 7(Picture) Black mould in places

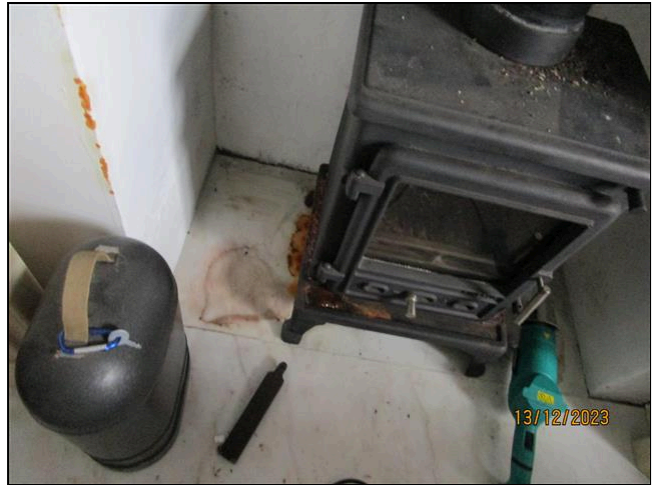
3.0 Item 8(Picture) Damp to chimney breasts

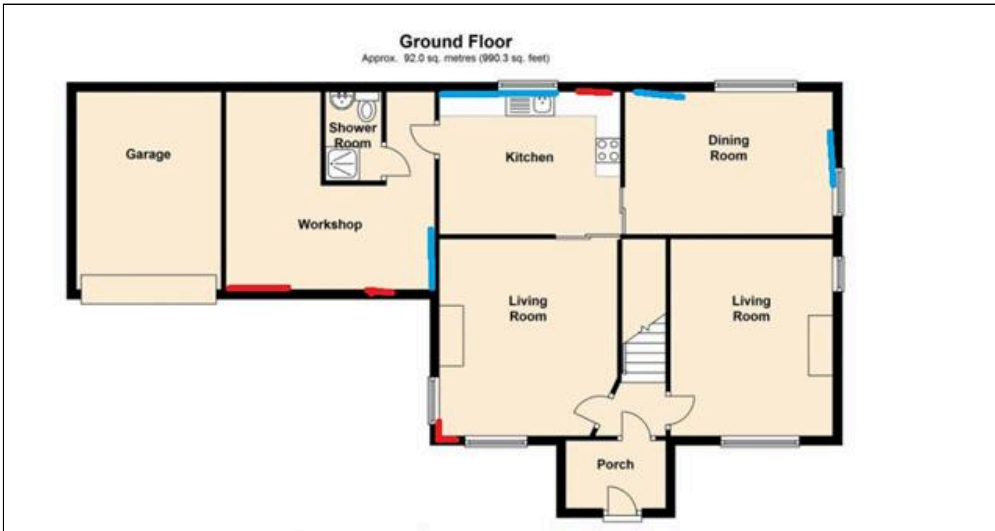
3.0 Item 9(Picture) Ground floor main damp areas

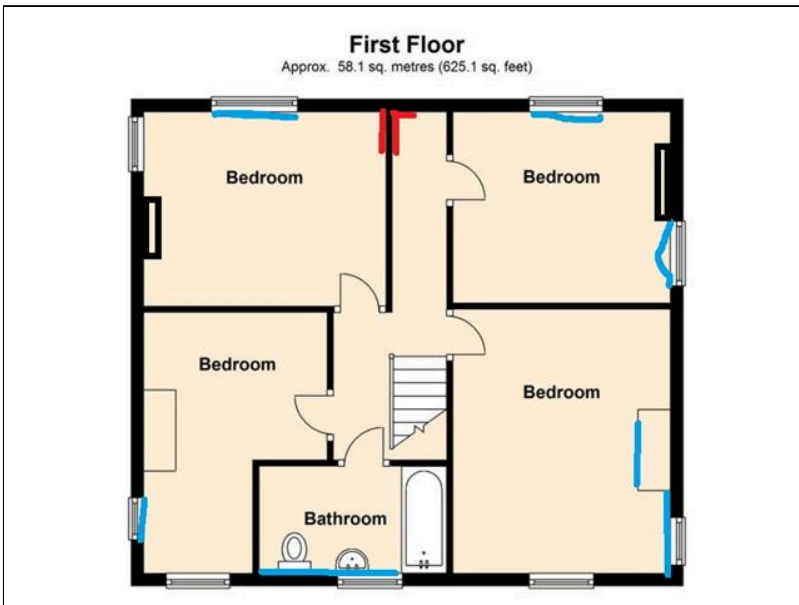
3.0 Item 10(Picture) First floor main damp areas

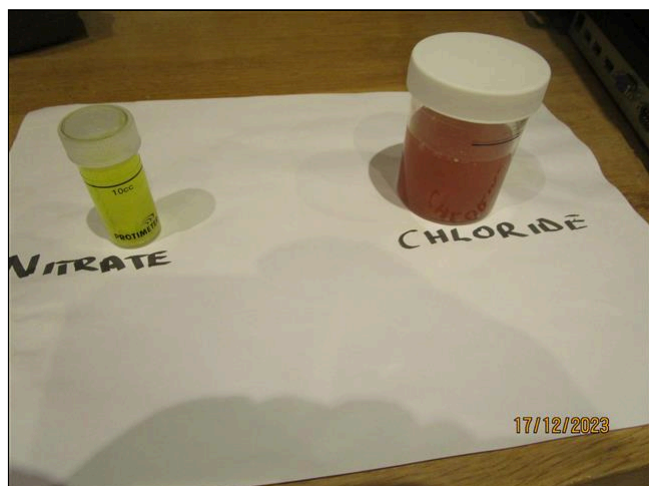
3.1 Item 1(Picture) No salts - Kitchen wall

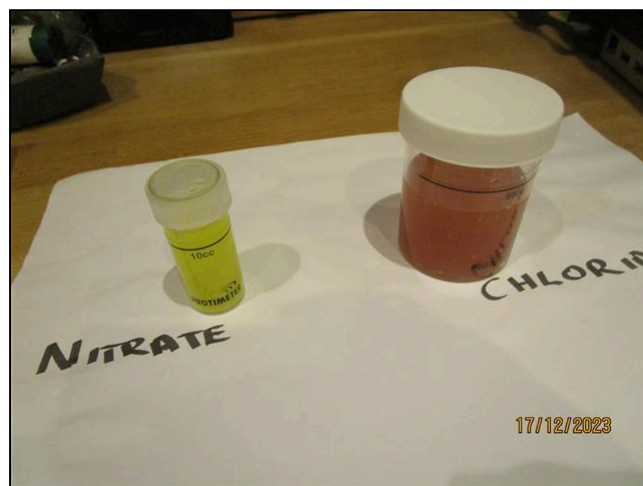
3.1 Item 2(Picture) No salts - Utility wall next to Kitchen

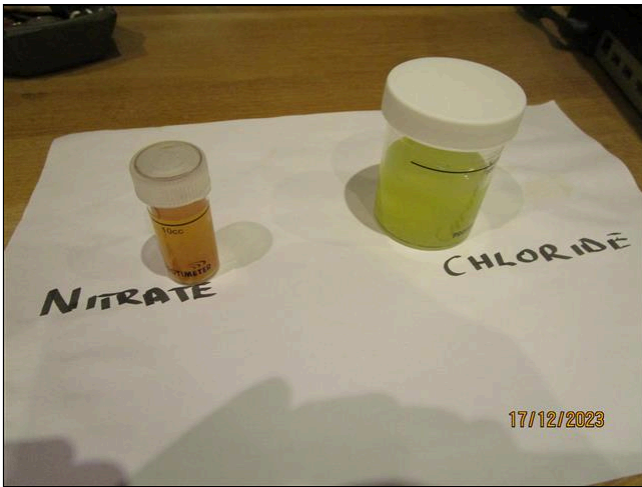
Whilst this is a rare result it points towards condensation and some ground water.

This would back up the suspicion that there was no DPC on the brick wall of the Utility Room.

3.1 Item 3(Picture) Nitrates found on Utility wall below window

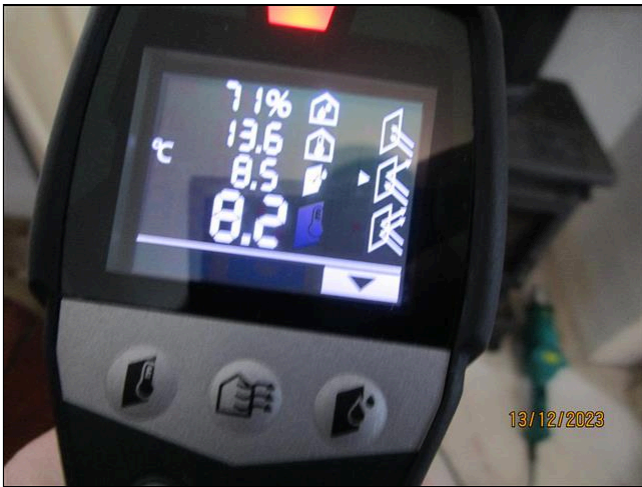
This indicates that condensation was occurring at the time of inspection.

3.2 Item 3(Picture) Condensation occurring in some rooms

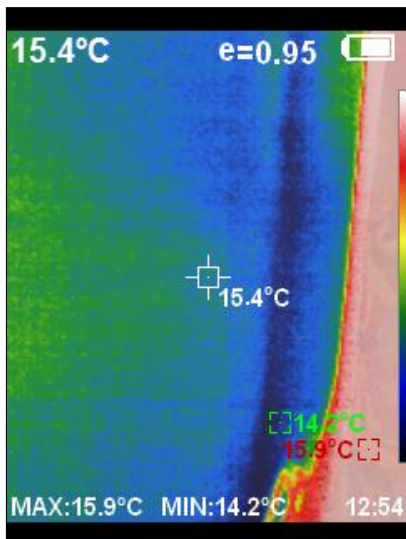
3.3 Item 1(Picture) Cold walls - not drylined

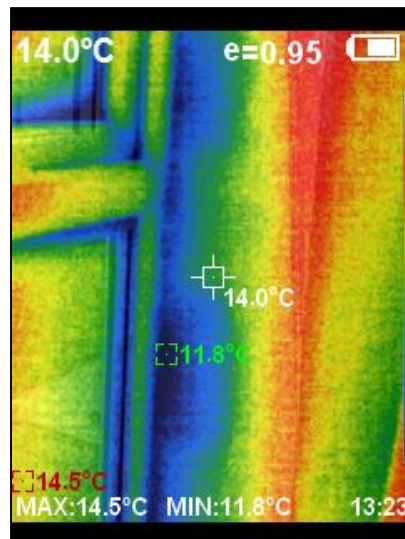
3.3 Item 2(Picture) Condensation on windows

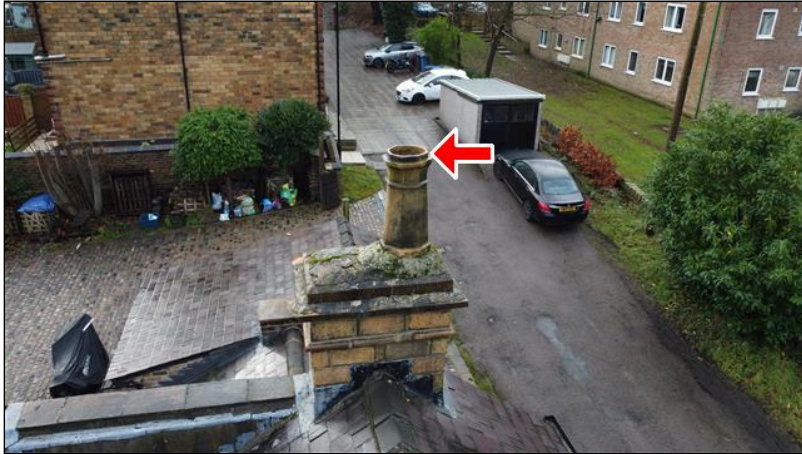
Some Flaunching was cracked/loose and this may allow water ingress.

4.2 Item 1(Picture) Chimney no cowl

- 2 The chimneys must be checked and any damaged Flaunching/Flashing repaired.
The open pot needs a cowl fitting.
The two holes at the rear must be covered over or new pots fitted.
Any removed pots should have ventilation fitted externally and internally.

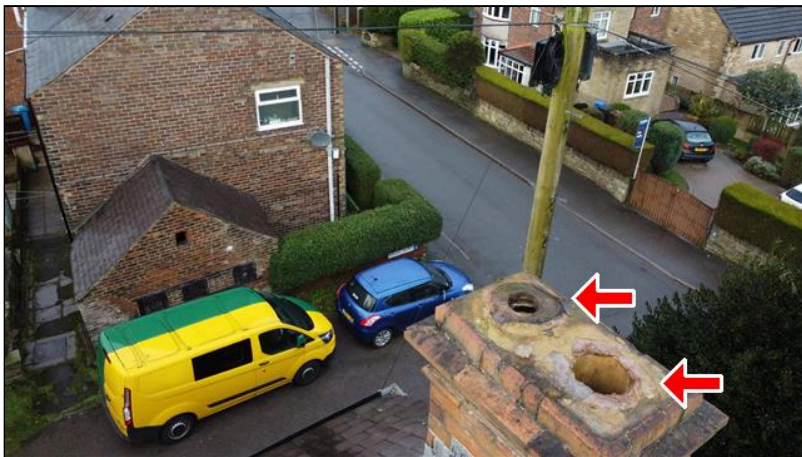
4.2 Item 2(Picture) Holes where pots removed

The chimney to the rear Right has both pots missing and there are two holes allowing water to access the stack.

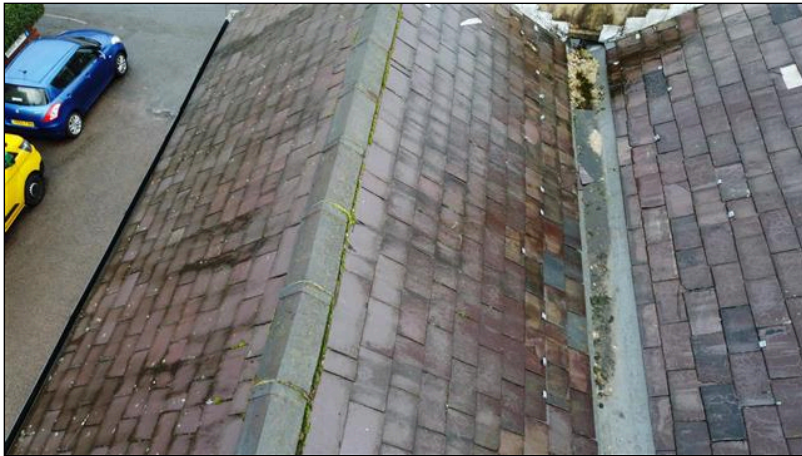
There are some cracked/slipped tiles evident.

5.2 Item 1(Picture) Double roof

- 2 The roof should be checked and any damaged tiles repaired/replaced.
The valley and parapet should be checked and made watertight.
This could be carried out at the same time as the chimney repairs.

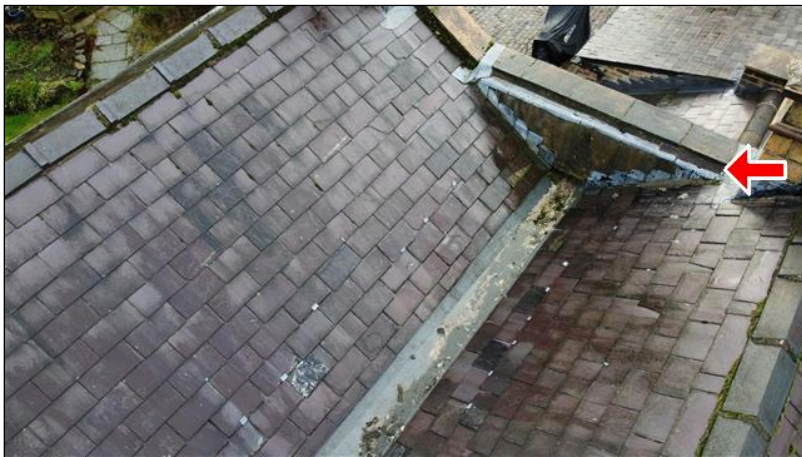
The roof is a double roof with a valley in between with parapets at either end. Parapets are notorious for allowing water ingress and I noted debris and standing water. There is Lead Flashing around the parapet to help keep water out however, there seems to be gaps which may allow water in.

I noted debris in the valley and there seems to be adhesive tape around the parapet.

5.2 Item 3(Picture) Roof valley with parapet

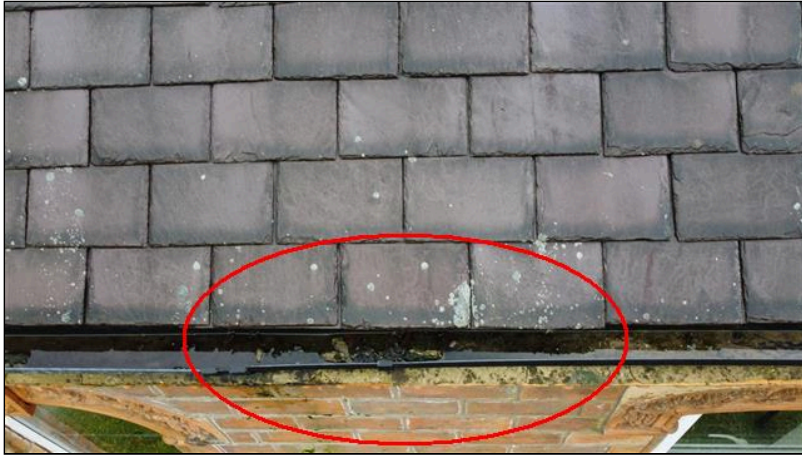
The rear gutter was seen to be leaking above the rear Landing window and there was internal damp/ damage here.

6.2 Item 1(Picture) Gutter leak and standing water

The gutters look to be leaking and the fall to downpipes is not enough and this is resulting in standing water. In heavy rain, it is likely that they will overflow here.

3 The gutters need checking and repairing/replacing.

The fall to the downpipes should also be checked to ensure that water runs along to each downpipe.

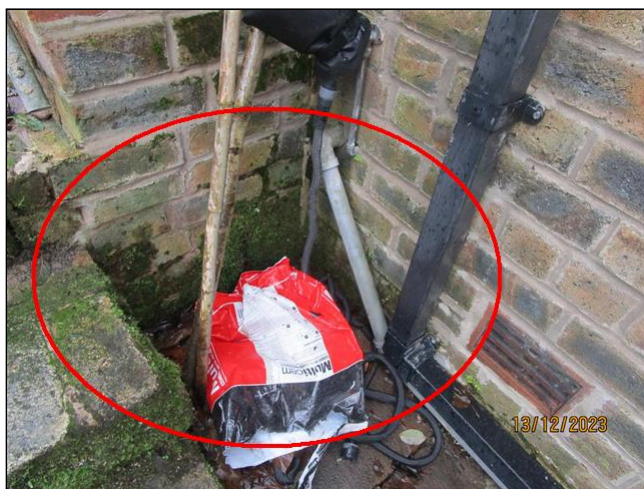
The step/wall to the front Right corner of the Utility Room, along with the leaking tap, seems to be causing penetrating damp internally.

7.2 Item 1(Picture) Penetrating damp to Utility wall

The leaking tap needs repairing.

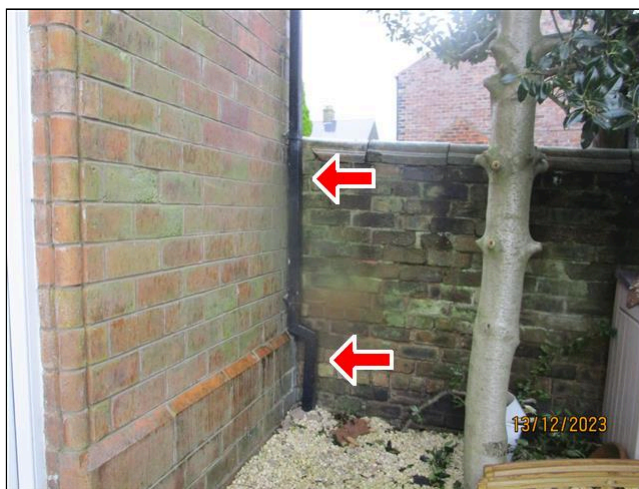
The boundary wall to the rear Right corner may cause penetrating damp when wet.

7.2 Item 2(Picture) Boundary wall abutts main wall

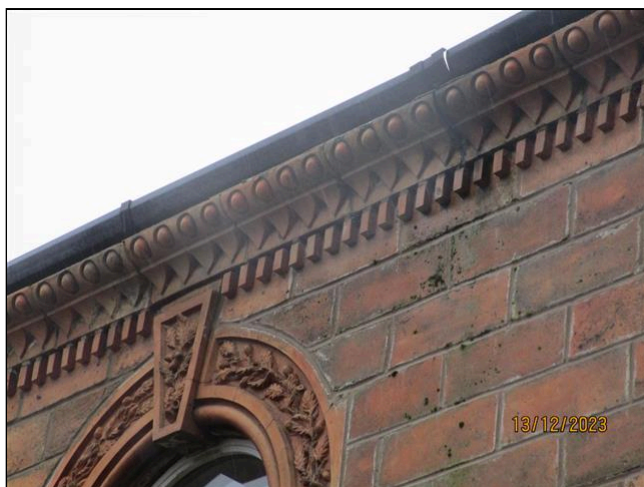
The new pointing should be Lime rather than cement as cement can trap water internally and is also inflexible. This may cause cracks to the stone as it expands and contracts.

7.2 Item 3(Picture) Walls recently repointed

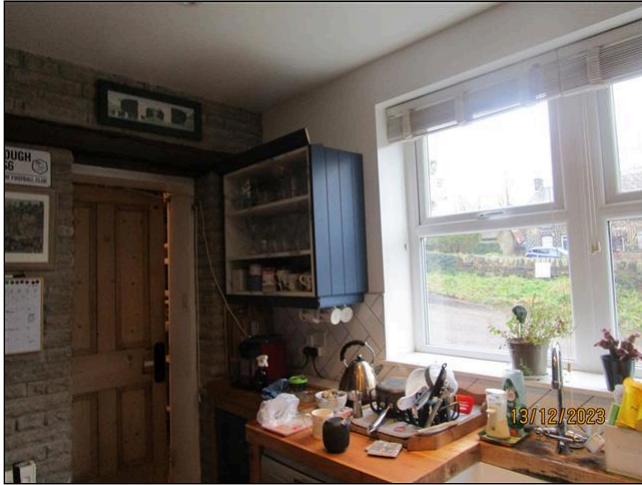
8.2 Item 1(Picture) Windows have no trickle vents

The windows, if not being replaced, should have trickle vents retro fitted.

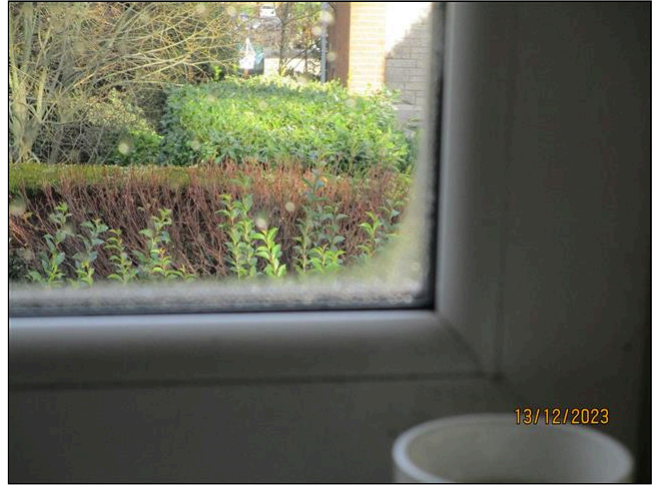
8.2 Item 2(Picture) Water droplets from condensation

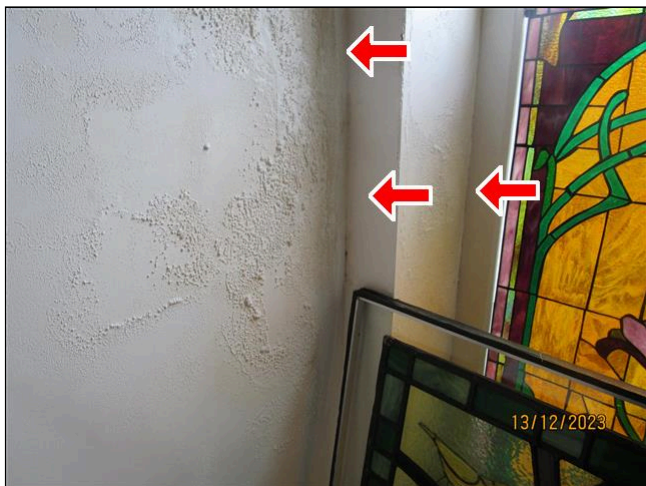
There are areas of mould, bubbling plaster and high condensation/moisture readings to many areas.

The causes are mostly condensation and penetrating damp.

9.2 Item 1(Picture) Damaged wall plaster

The causes of the damp must be tackled first and then the walls can be redecorated.

The internal walls affected by damage should be taken back to the stone and re-plastered with a salt retardant plaster. This will reduce the risk of Hygroscopic salts which draw moisture from the air.

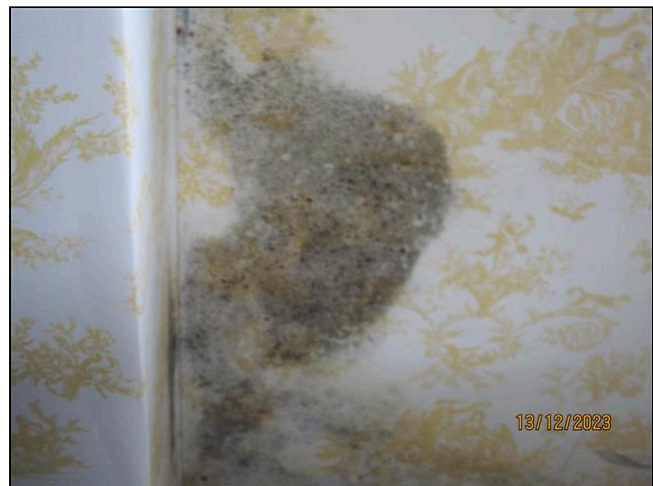
9.2 Item 2(Picture) Black mould on some walls

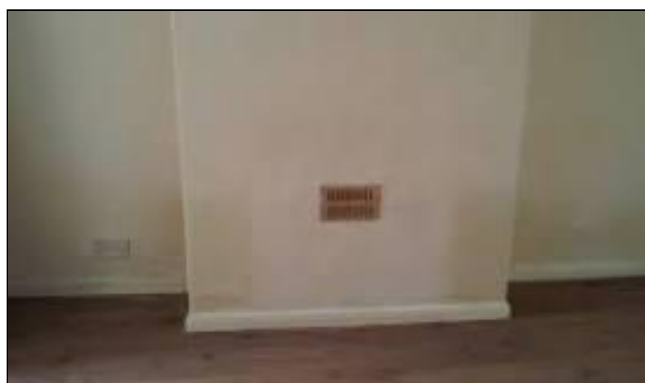
It was noted that the unused chimney breast was not vented, this may allow condensation to develop.

10.2 Item 1(Picture) Instal vents should be fitted

- 2 The external defects must be repaired - See Section 4.
- Internally the unused chimney breasts should be vented to reduce the risk of condensation.
- If there is continual damp at the base of the chimney then a DPC will be needed.

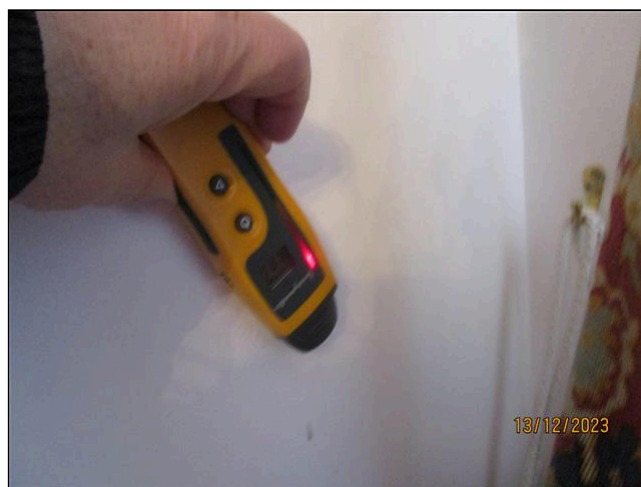
Some spots of high moisture were noted in places, indicating condensation is occurring.

10.2 Item 2(Picture) Damp spots noted

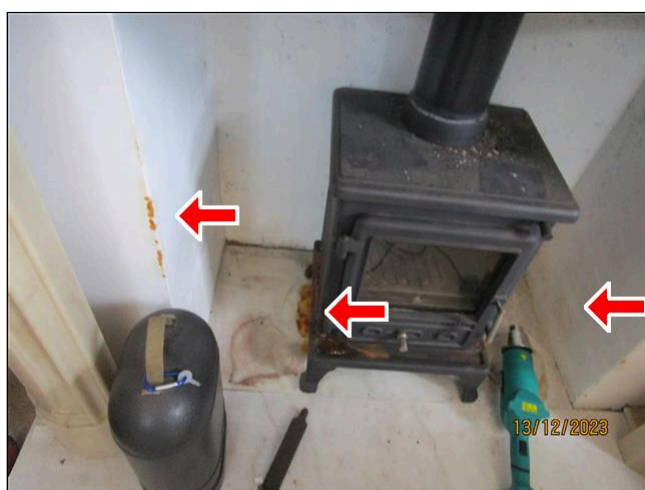
The Right chimney breast had signs of damp in the form of rusting to the fire and wall plaster beading, high moisture readings and mould.

10.2 Item 3(Picture) Rust and damp noted

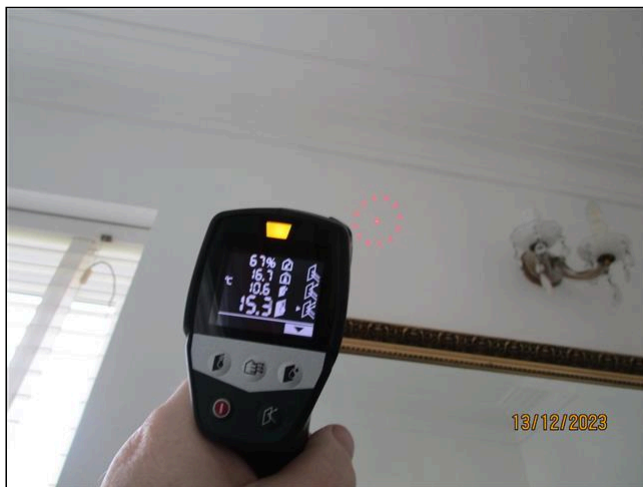
This increases the levels of moisture within the room and hence increases the risk of condensation to the walls and ceiling structures.

11.0 Item 1(Picture) Raised condensation readings in Bathroom

Mechanical extract ventilation must be installed to improve ventilation and reduce risk of condensation.

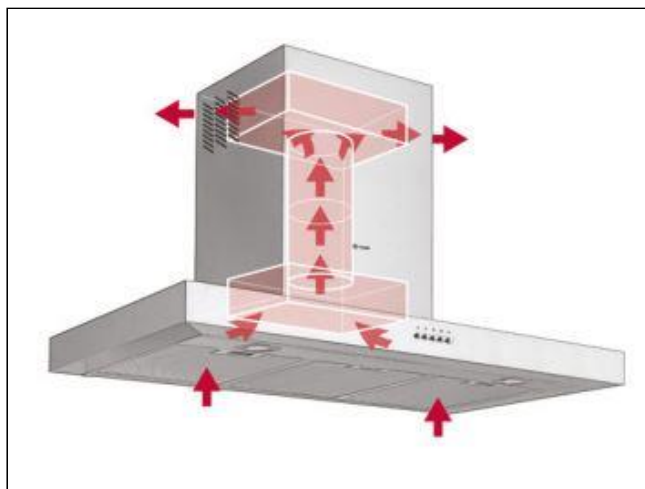
This increases the levels of moisture within the room and hence increases the risk of condensation to the walls and ceiling structures.

11.1 Item 1(Picture) Recirculation system

Mechanical extract ventilation must be fitted and used at all times.
